Challenges when retrofitting multi-storey buildings with interior thermal insulation

Odgaard, Tommy Riviere

Citation (APA):
Odgaard, T. R. (2019). *Challenges when retrofitting multi-storey buildings with interior thermal insulation*. Technical University of Denmark, Department of Civil Engineering. B Y G D T U. Rapport No. R-386

Challenges when retrofitting multi-storey buildings consisting of solid masonry facades and embedded wood with interior thermal insulation

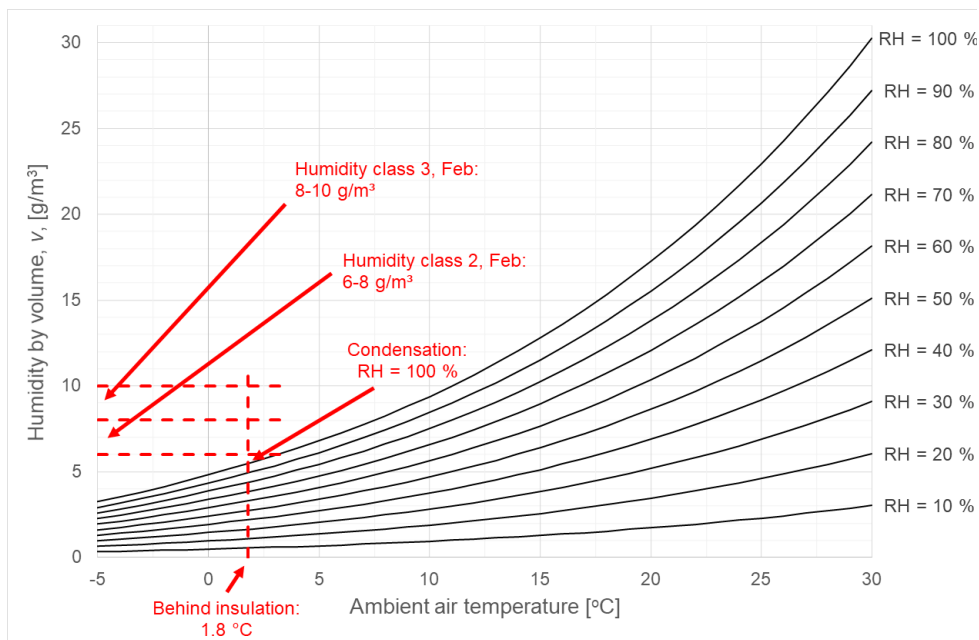
Figure 8 Water vapour diagram. Calculations based on (DS/EN ISO 13788:2013, 2013), diagram composition inspired by similar diagram in (Brandt et al., 2013). Temperature behind insulation based on steady state calculation in Figure 7.

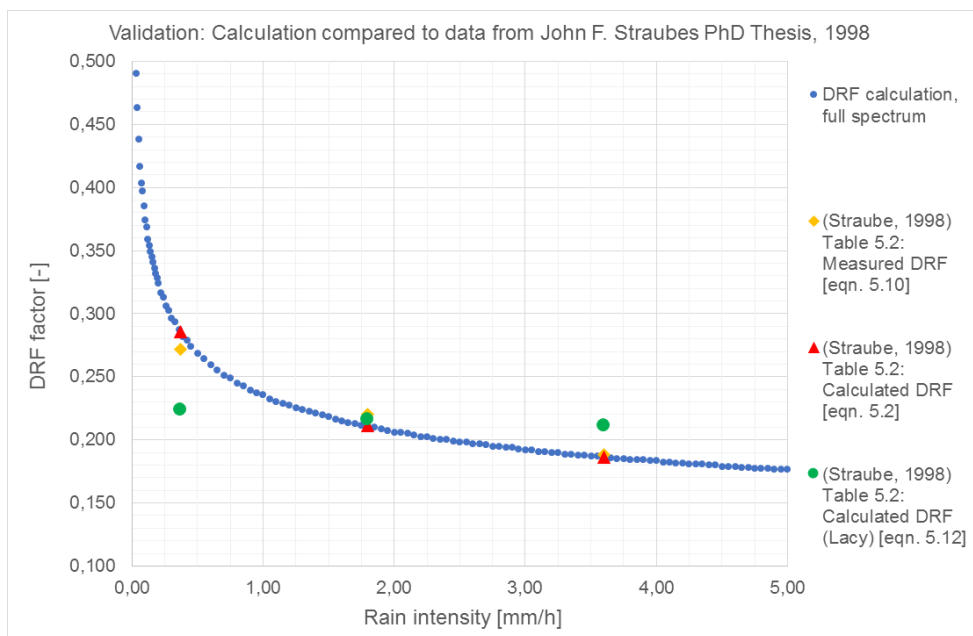
Figure 9 Calculation of varying DRF with rain intensity, compared with table values from Straubes PhD Thesis (Straube, 1998).
